## An Experimental Investigation of the Failure of a Stepped Composite Plate

Thesis by  
Steven C. Gortsema

In Partial Fulfillment of the Requirements for the Degree of  
Aeronautical Engineer

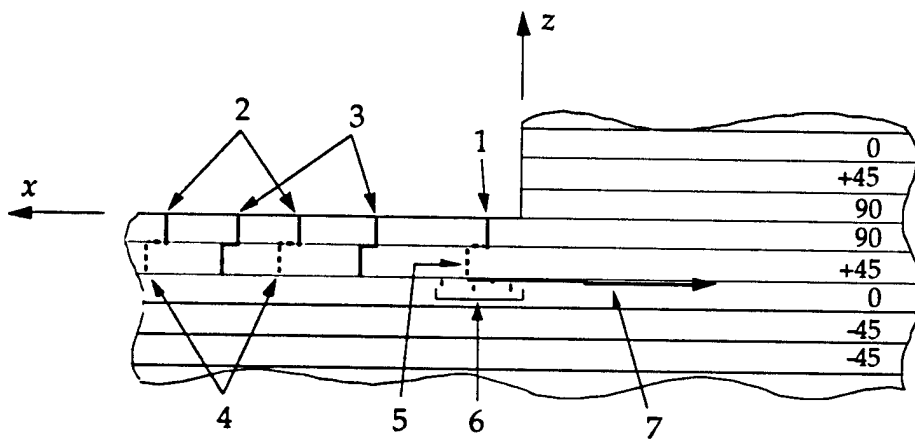
Figure 9. Damage development on the positive edge.\*\*

1.  $\{M = 39\% \text{ of } M_{fp}\}$  The  $90^\circ$  ply (plate interface ply) cracks near the step, usually at values of  $x$  between 1 and  $1\frac{1}{2}t$ , where  $t$  is the ply thickness (Figure 10a).

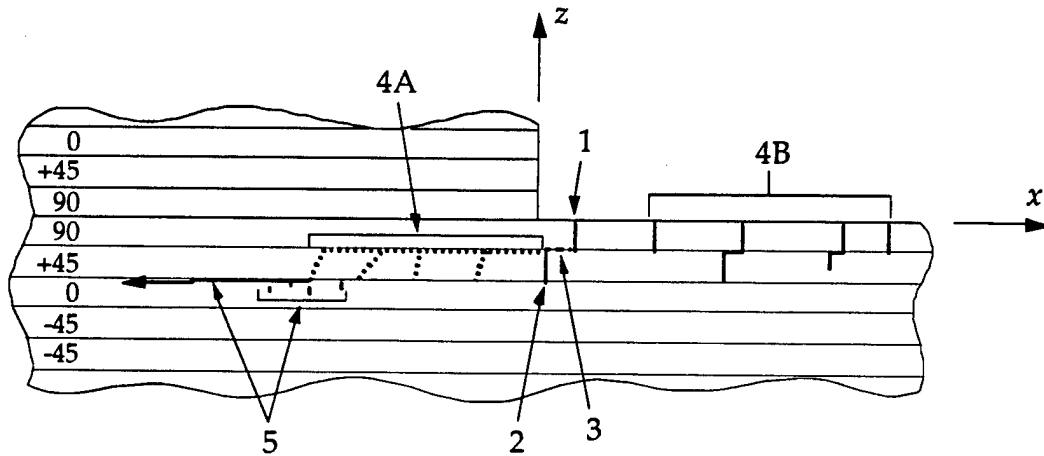
Figure 11. Damage development on the negative edge.

1.  $\{M \approx 41\% \text{ of } M_{fn}, \text{ where } M_{fn} \text{ is the moment loading at ultimate failure for this specimen}\}$  The first damage seen on the negative edge is also the cracking of the  $90^\circ$  ply near the step (Figure 12a).<sup>††</sup> This crack, and the others which later develop in the  $90^\circ$  ply, cross the entire width of the specimen.\*

- (i) This process usually begins with the interface crack propagating farther away from the step and then turning into the  $45^\circ$  ply. However, sometimes the crack in the  $45^\circ$  ply appears before the extension of the interface crack, as shown by the crack near the bottom of Figure 12c. In Figure 12d, the same interface crack propagated farther along the specimen before turning into the  $45^\circ$  ply.
- (ii) Next, the  $45^\circ$  ply crack farthest from the step grows almost all the way across the ply. Then the delamination crack (interface crack) grows along the interface, and turns into the  $45^\circ$  ply again. This process is repeated several times as the load is increased (Figure 12e, "4A" in Figure 11).

As this delamination process starts to occur, additional cracking begins to develop on the plate edge on the other side of the step where  $x$  is greater than zero ("4B" in Figure 11). Some of these new cracks cross both the  $90^\circ$  and  $45^\circ$  plies, but the damage by the corner appears the most severe throughout the entire test when viewing the negative edge.

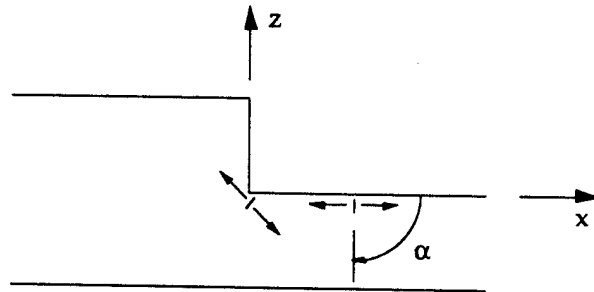
run straight across the plies, regardless of how close they are to the corner. This observation seems to contradict the numerical, asymptotic solution by Kubr, which would indicate that the lines of principal stress in the plate interface ply directly below the step (-z direction) are  $45^\circ$  different from the lines of principal stress in the same ply out away from the step (+x direction) (Figure 13).

Figure 13. Directions of maximum normal stress calculated from the results of Kubr's numerical study.

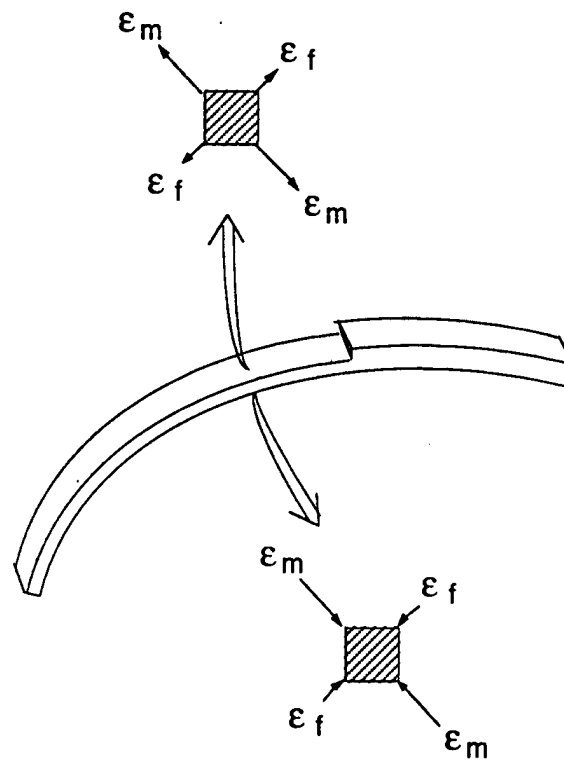
One other effect which contributes to the location of maximum stress is the twisting of the specimen. This effect is mainly caused by the 45° plies near the surface of the plate, as shown in Figure 14. For a given axial stress, there is a larger strain transverse to the fibers than parallel to them. This skews the axis about which the specimen bends, giving a smaller radius of curvature, and therefore a higher bending stress, along the negative edge.

Figure 14. Specimen twist mechanism.

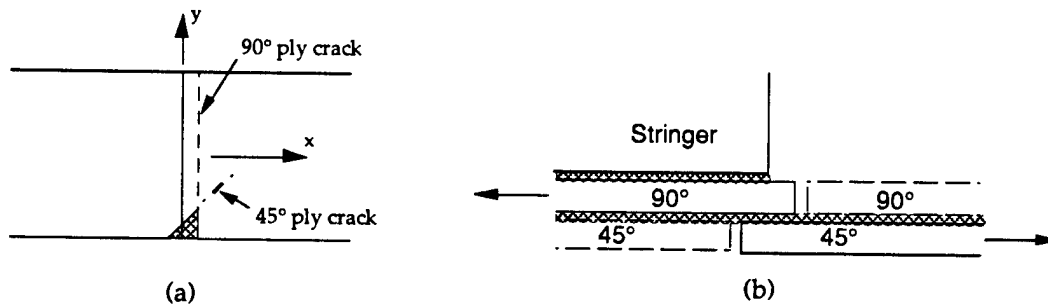
When a crack in the  $45^\circ$  ply forms near the end of the step by the negative edge, a triangular region of the interface is isolated (Figure 15a), causing it to be loaded with a very high shear stress. This is most easily seen by considering a force-balance diagram of the cracked portion of the specimen near the negative edge (Figure 15b):

Figure 15. Region of high shear stress.  
(a) plan view (b) negative-edge view.

The plies are under a tensile loading away from the crack because of the bending. Since both the  $90^\circ$  and  $45^\circ$  plies are unable to support a tensile stress near the transverse cracks, the entire force is transferred through the small overlapping region of the interface. This makes the shear stress in this area very high, causing the interface to fracture. Therefore, for this lay-up, the damage development indicates that delamination initiation is caused by interlaminar shear stress.\* Although this feature appears to be a direct result

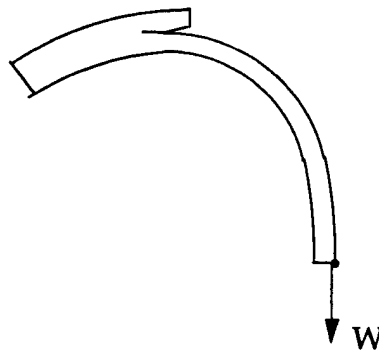
- (ii) The discontinuity in bending stiffness also contributes to this opening stress since the plate tends to deflect much more easily than the plate-stringer combination (Figure 17).

Figure 17. Delamination caused by different bending stiffnesses.

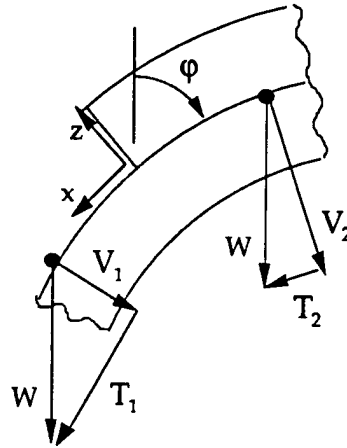
One difficulty in partially attributing the delamination propagation to beam shear force is that in a two-dimensional drawing, this seems to be an unstable process. Figure 18 implies that as the delamination crack tip moves in the  $-x$  direction, the shear force at the crack tip increases if the load angle,  $\phi$ , is less than  $90^\circ$ . This apparent instability seems to contradict the negative-

Figure 18. The relation of beam shear force to delamination tip position.

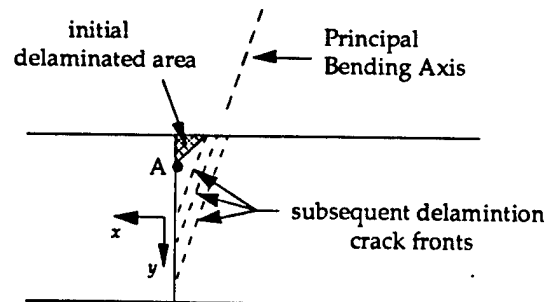
However, when viewing the delamination crack front in plan view (Figure 19), one realizes that the amount of new surface area per unit crack advance increases as the delamination grows across the specimen. In terms of the Griffith criterion for crack advance, this increases the total energy required for each subsequent unit of crack propagation. Therefore, since the required energy is increasing as the shear force is increasing, it is no longer clear whether the process is unstable.

Figure 19. Plan view of delamination crack advance.

- (i) After the initial  $45^\circ$  triangular delamination crack forms, the highest stress is at point A in Figure 19.
- (ii) The part of the crack front by point A then propagates until the crack front is parallel to the principal bending axis.
- (iii) The crack front then advances uniformly until it reaches the positive edge of the specimen.

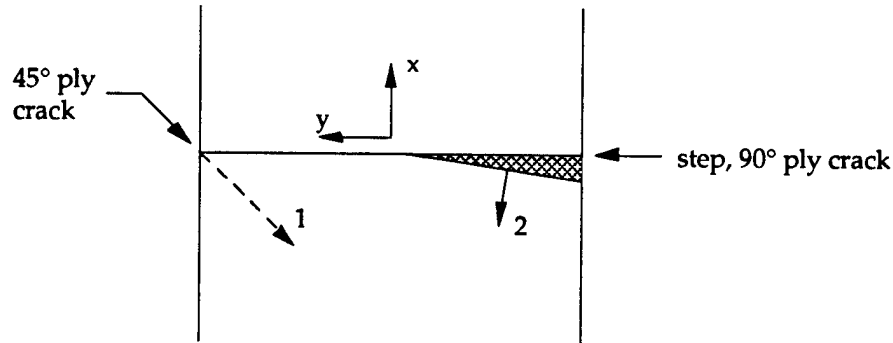
the  $y$  component of the  $45^\circ$  ply crack-opening displacement, which is believed to have two sources (Figure 23):

Figure 23. Contributions to "mode III" displacement.

First, as the crack in the  $45^\circ$  ply propagates into the specimen, the crack-opening displacement at the free edge increases. Second, as the  $90/45$  delamination spreads across the specimen, the curvature of the  $45^\circ$  ply increases as the portion of the plate below the delamination ( $-z$  direction) peels away from the stringer and  $90^\circ$  ply above the delamination. This increase in curvature causes the tensile stress in the  $45^\circ$  ply to increase ahead of the delamination tip as well as behind it, thus increasing the opening stress and crack-opening displacement of the  $45^\circ$  ply crack near the corner. This second contribution is believed to be the cause of the damage noise which preceded the perceived mode III displacement.

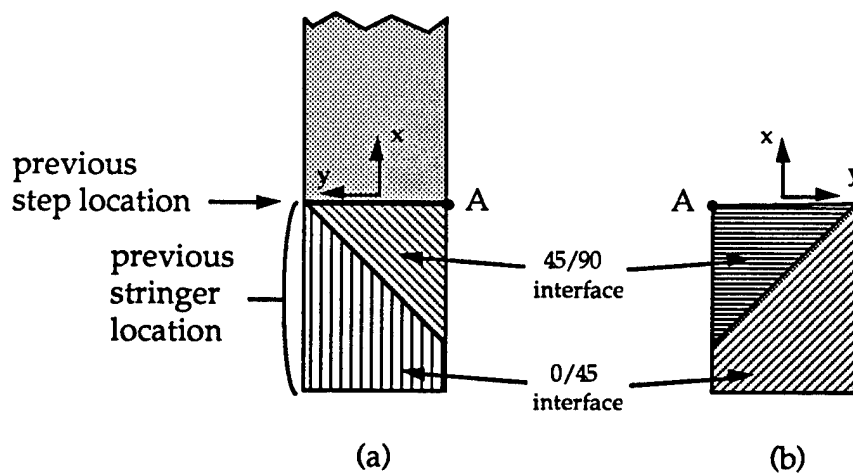
The details of the 45/0 delamination are most easily recognized by analyzing the fracture surface. In all of the case 1 and 4 specimens, the fracture surface can be represented by Figure 24.

Figure 24. Fracture surface of case 1 and 4 specimens. (a) Plate side of the fracture surface. (b) Stringer side of the fracture surface.

Since the first two alternative mechanisms shown in Figure 25 require large numbers of fibers to fracture and separate, it is easy to see on physical grounds why the observed fracture surface requires less energy. For the surface of Figure 24 to be created, the  $90/45$  delamination crack must continue

Also, a significant opening stress in this region due to bending would require a sizable change in bending stiffness between the portion of the plate with the 90° plate interface ply and the portion without it. This also does not occur. Therefore, the stress levels needed to delaminate the 90/45 interface on the +x side of the step do not exist. This makes it clear why the fracture surface consistently appeared as shown in Figure 24.

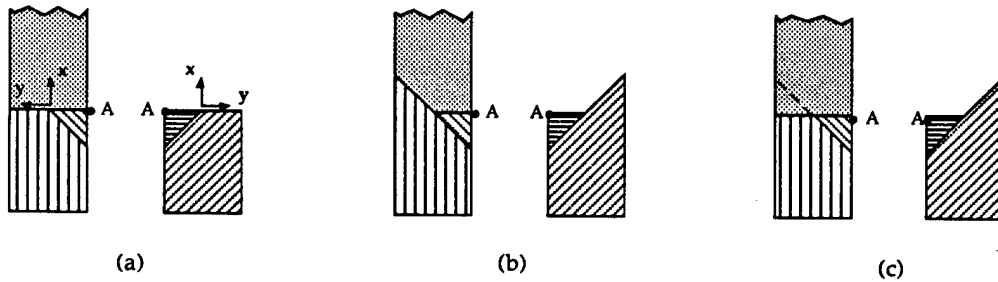
Figure 25. Alternative fracture surfaces.

The  $90^\circ$  plate interface ply prevents the  $45^\circ$  ply below it from separating freely at values of  $x$  greater than that for the  $90^\circ$  crack. One way in which the  $45^\circ$  ply can peel away from the plate differently than shown in Figure 24 is if some of the fibers break where they cross the  $90^\circ$  ply crack (Figure 25a). Another method that allows this to be achieved requires the  $90^\circ$  fibers in the plate interface ply to break where they cross the  $45^\circ$  ply crack (Figure 25b). One other way is for the  $90/45$  and the  $45/0$  interfaces to delaminate by the triangular portion of the  $45^\circ$  ply protruding above the step (Figure 25c). This will then allow the  $45^\circ$  ply to be pulled out from underneath the  $90^\circ$  ply when it separates.

Even though the third mechanism which would allow the  $45^\circ$  ply to separate at positive values of  $x$  usually involves less total delamination area, it doesn't occur because the stresses are much less where  $x$  is positive. In particular, the mode I opening stress for the  $90/45$  interface is almost negligible on the  $+x$  side of the  $90^\circ$  separation crack. Neither of the mechanisms which contribute to delamination propagation have a significant effect on the peel stress in this region. As illustrated in Figure 26, the existence of a significant interlaminar tensile stress caused by beam shear force requires the  $90^\circ$  ply to move in the opposite direction as the  $45^\circ$  ply does. This is not the case on the  $+x$  side of the  $90^\circ$  separation crack.

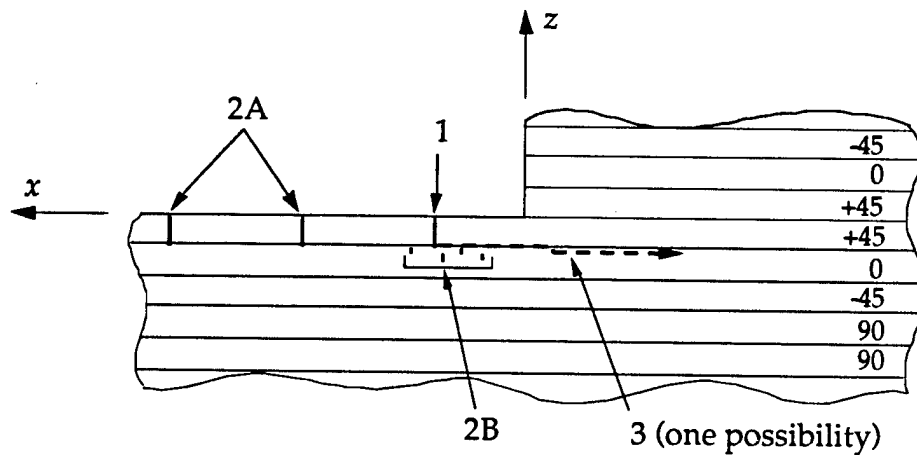
Figure 27. Damage development on the positive edge.

1.  $\{M \approx 77\% \text{ of } M_{fp}\}$  Damage is normally heard before the first crack is seen, indicating that damage does not initiate on the positive edge. However, when the first crack does reach the edge, it is usually a few ply thicknesses away from the corner (Figure 28a).
2.  $\{M \approx 93\% \text{ of } M_{fp}\}$  As the load angle increases, more cracking is seen farther away from the step at larger values of  $x$  (shown by "2A" in Figure 27). However, not nearly so many cracks develop on the edges of the case 2 specimens as did for cases 1 and 4. When viewing the positive edge of a case 2 specimen, only 2 or 3 cracks are seen before failure, compared with over a dozen cracks in the case 1 and 4 tests.

At approximately the same load,  $0^\circ$  fiber fractures are often observed ahead of the  $45^\circ$  ply crack nearest the corner (shown by "2B" in Figure 27). In some cases this crack even turns and begins to propagate stably in the  $-x$  direction along the  $45/0$  interface (Figure 28b).

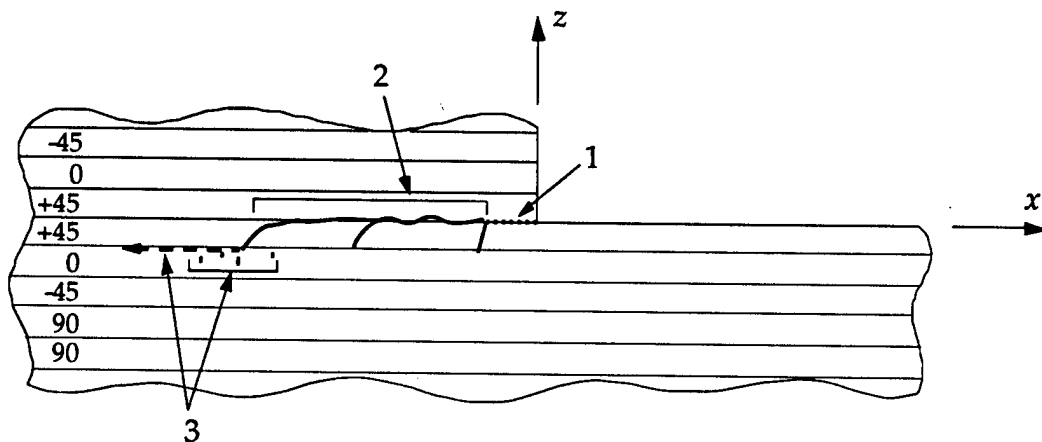
Figure 29. Damage development on the negative edge.

1.  $\{M \approx 70\% \text{ of } M_{fn}\}$  The first damage to appear on this edge is a crack on the 45/45 interface. This crack originates from the corner and travels in the  $-x$  direction. Unlike case 1 and 4 tests, the delamination here does not usually occur after the appearance of a crack in the  $45^\circ$  ply. The significance of this

2.  $\{M \approx 70\% - 90\% \text{ of } M_{fn}\}$  As the load increases, the delamination propagates along the 45/45 interface as discussed previously for case 1 and 4 specimens: The crack propagates along the interface, turns into the 45° plate interface ply, then resumes its propagation along the interface. As before, this process is repeated several times. However, for this lay-up there is no well-defined interface (surface) which separates as the specimen peels apart. Instead the delamination crack tends to wander back and forth more across the 45° plies (Figure 30).
3.  $\{M = M_{fn}\}$  Eventually, the delamination moves to the 45/0 interface and causes catastrophic failure. The region where this occurs often contains broken 0° fibers.

It should also be pointed out that the only damage to appear on the negative edge was that associated with the delamination. No cracking was seen at larger values of  $x$  in the plate interface ply.

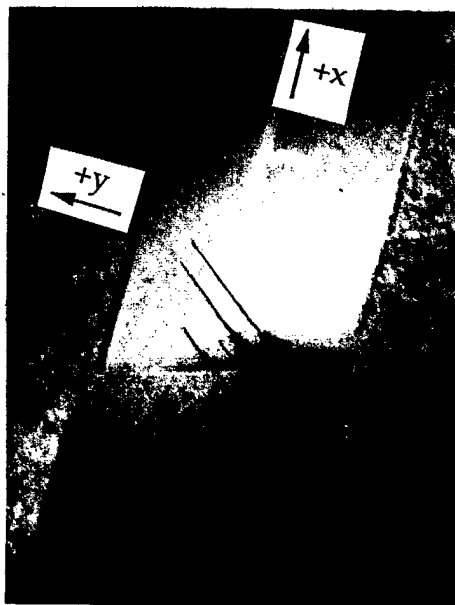
Several of the case 2 specimens were inspected post-mortem using penetrant dye.<sup>†</sup> The dye was applied to the top face of the plate near the step to learn more about the development of cracking in the 45° plate interface ply. The results of this inspection clearly showed that the cracks were scattered across the width of the specimen near the step. By comparing the cracks in a specimen that was not tested to catastrophic failure (Figure 32a) to one which had failed (Figure 32b), one can see that the cracks become more numerous as the test progresses. Also, inspection of one specimen which was tested only to

Figure 32.<sup>en</sup> Penetrant-dye inspection of the plate face.  
(a) prior to catastrophic failure. (b) after catastrophic failure.

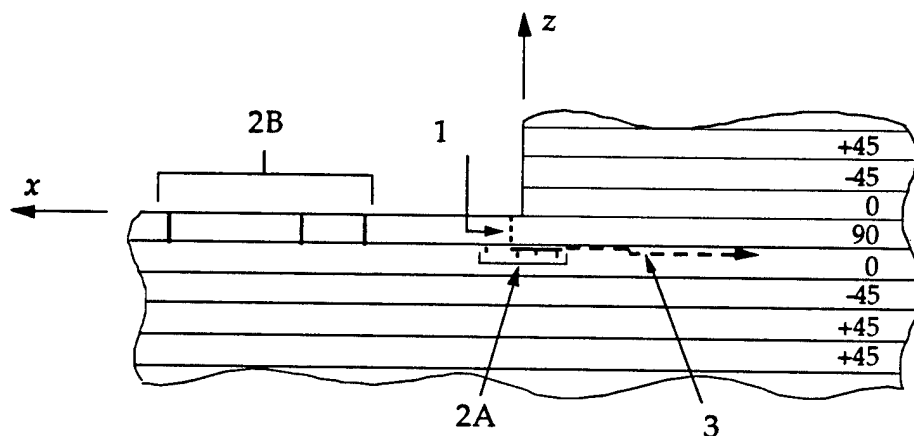
Figure 33. Damage development on the positive edge.

1.  $\{M \approx 45\% \text{ of } M_{fp}\}$  As in the case 1 and 4 tests, the damage process begins with a crack in the  $90^\circ$  ply near the step. However, for this lay-up the crack tends to be located closer to the corner (on average, about  $\frac{1}{4}$  of a ply thickness from the corner).
2.  $\{M \approx 95\% \text{ of } M_{fp}\}$  At sufficiently high local loading, the corner crack turns in the  $-x$  direction and propagates stably along the interface. As this happens, several fractures appear in the nearby  $0^\circ$  fibers ("2A" in Figure 33).

At approximately the same loading, additional cracking develops in the plate interface ply at larger values of  $x$  ("2B" in Figure 33). However, at no point in the test do these cracks appear more severe than the damage by the corner.
